PBY Catalina

Walk Around

By William Scarborough

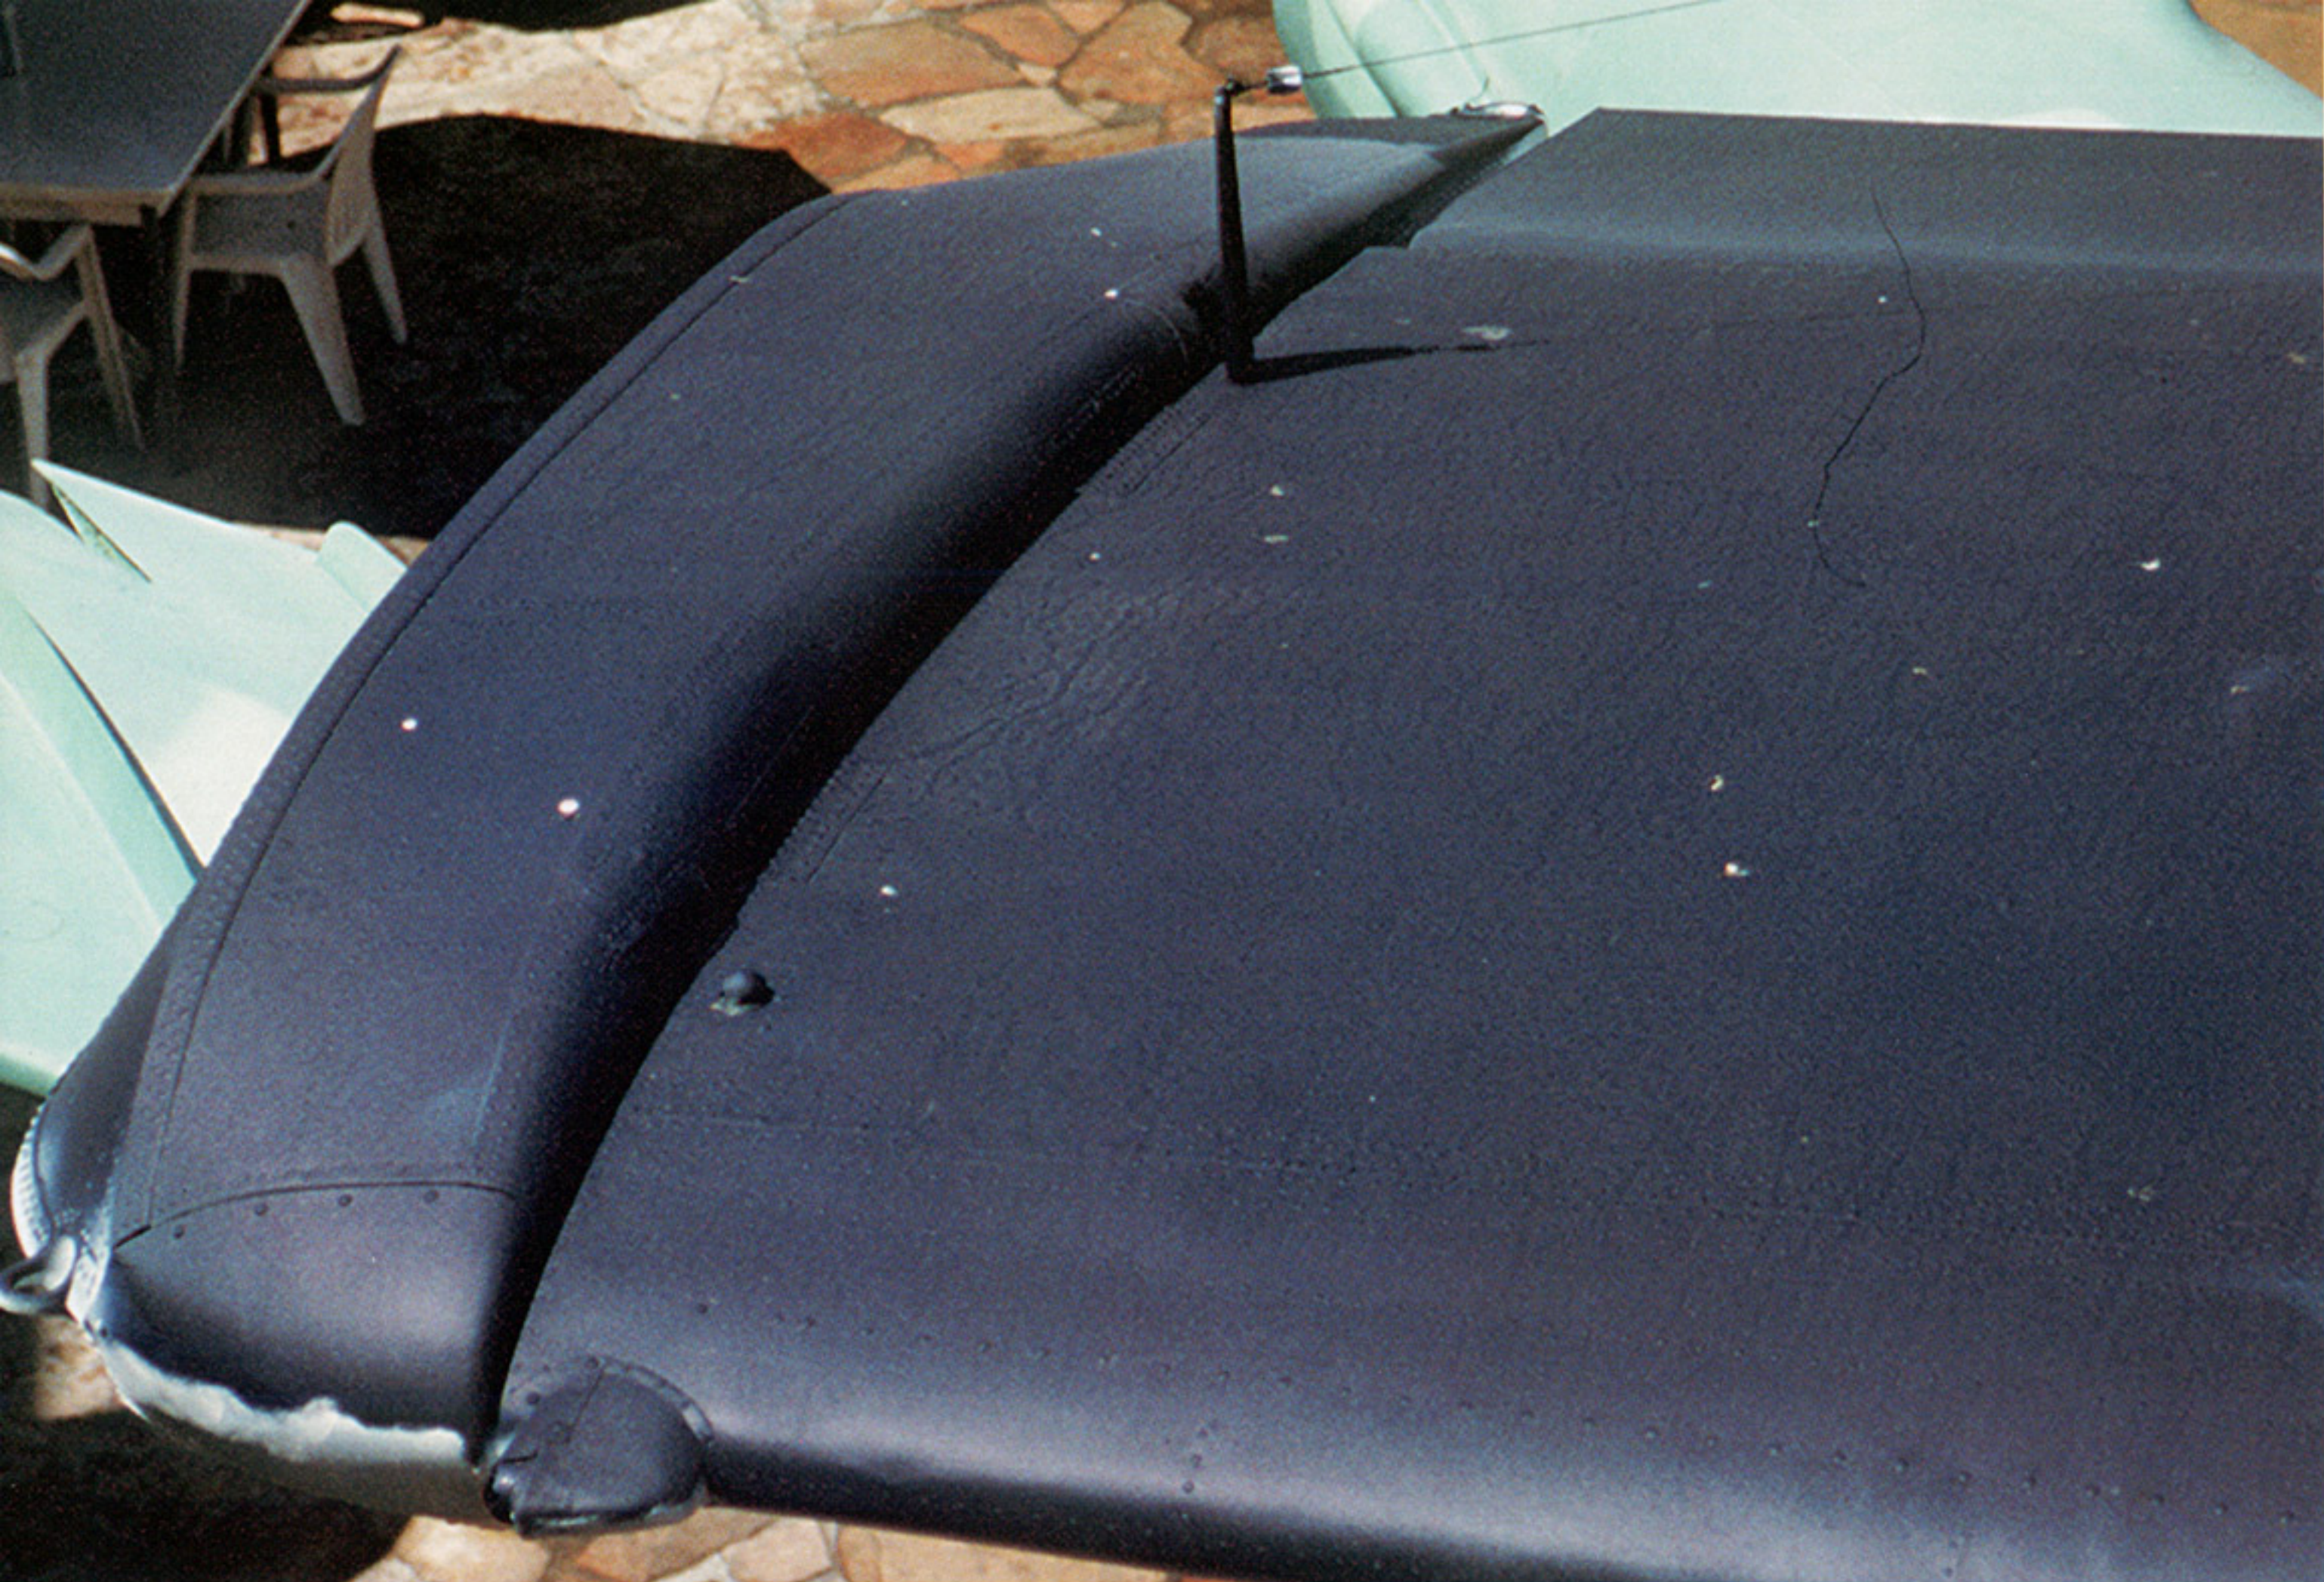
The retractable wing tip floats on the PBY-5A at the San Diego Aerospace Museum are in the fully retracted position. The rings on the front and rear of the float was tie down rings. The fairing at the wing leading edge just inboard of the float is the starboard position light, and the post near the wing trailing edge was the wing tip antenna mast. An antenna wire ran from this mast back to the forward leading edge of the vertical fin, while another wire ran from the fin to the opposite wing tip. (Mark Aldrich)

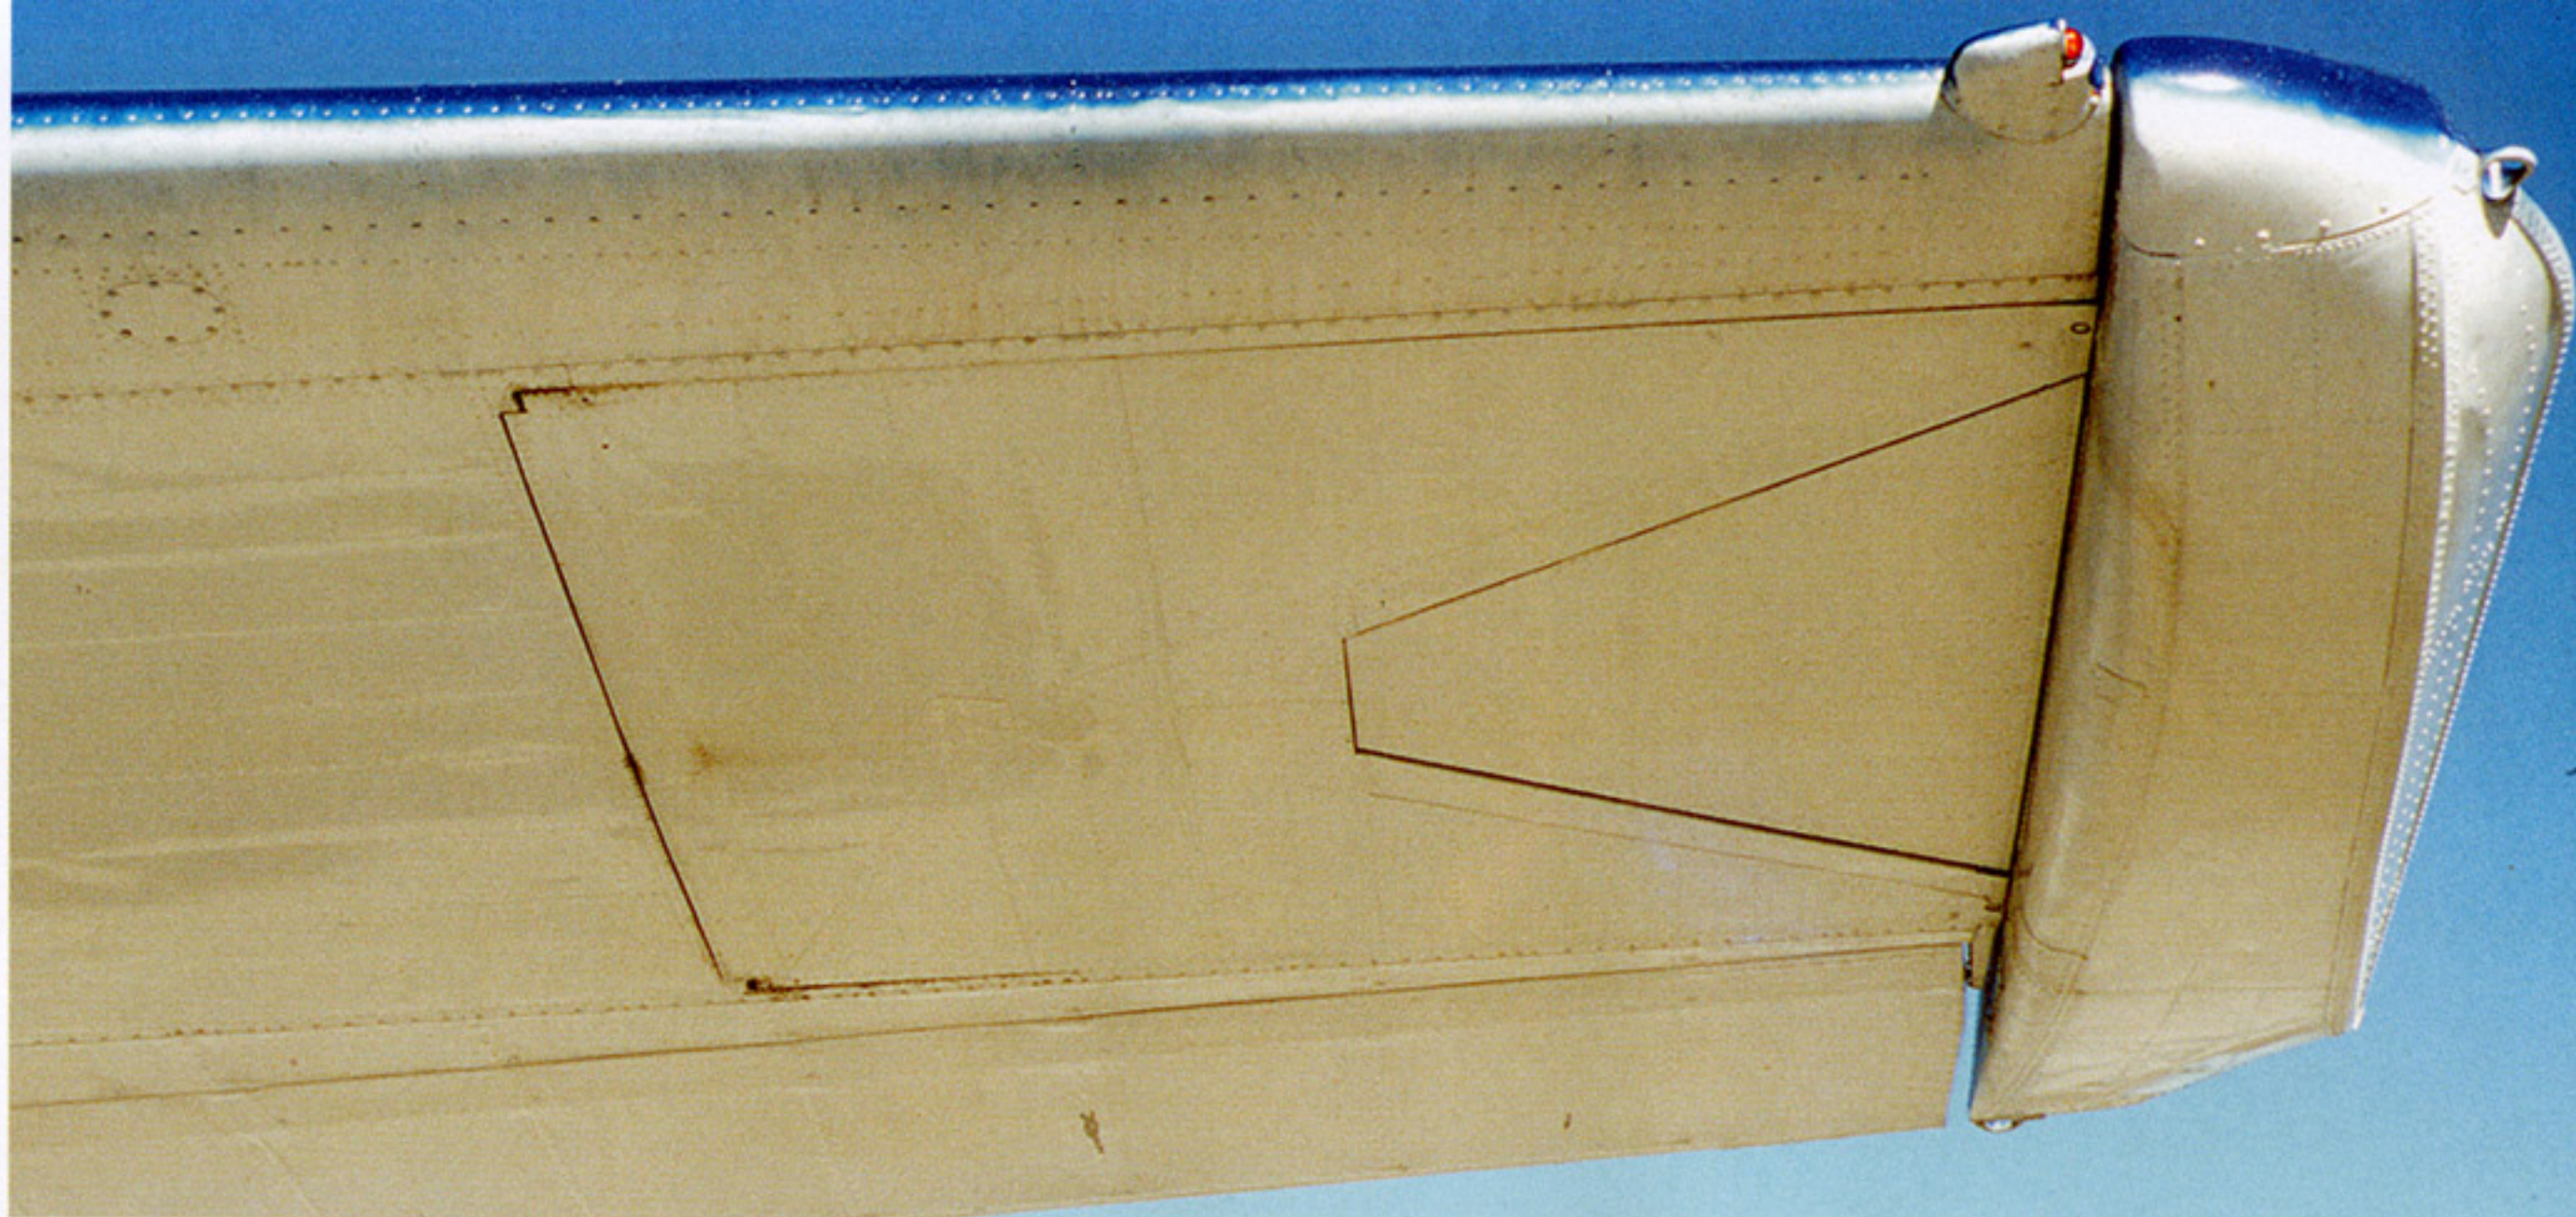
When retracted, the wing tip floats of the PB4Y fit flush with the tip of the wing while the doors fit flush with the underside of the wing. The V shaped section is a structural part of the lower wing surface and not a part of the float. The wing tip navigation light shines forward and outward and is shielded from the cockpit by the light fairing. The ring on the float front is a tie-down ring used to help secure the aircraft. When retracted, the float is held in position by the fully retracted actuating strut. The color demarcation line runs down the center of the float, with areas view from above painted in the upper surface camouflage color and areas viewed from below painted in the lower surface color. The aileron trim tab is also visible along with its actuating push rod. In rough air the floats could be observed flexing up and down. (Mark Aldrich)

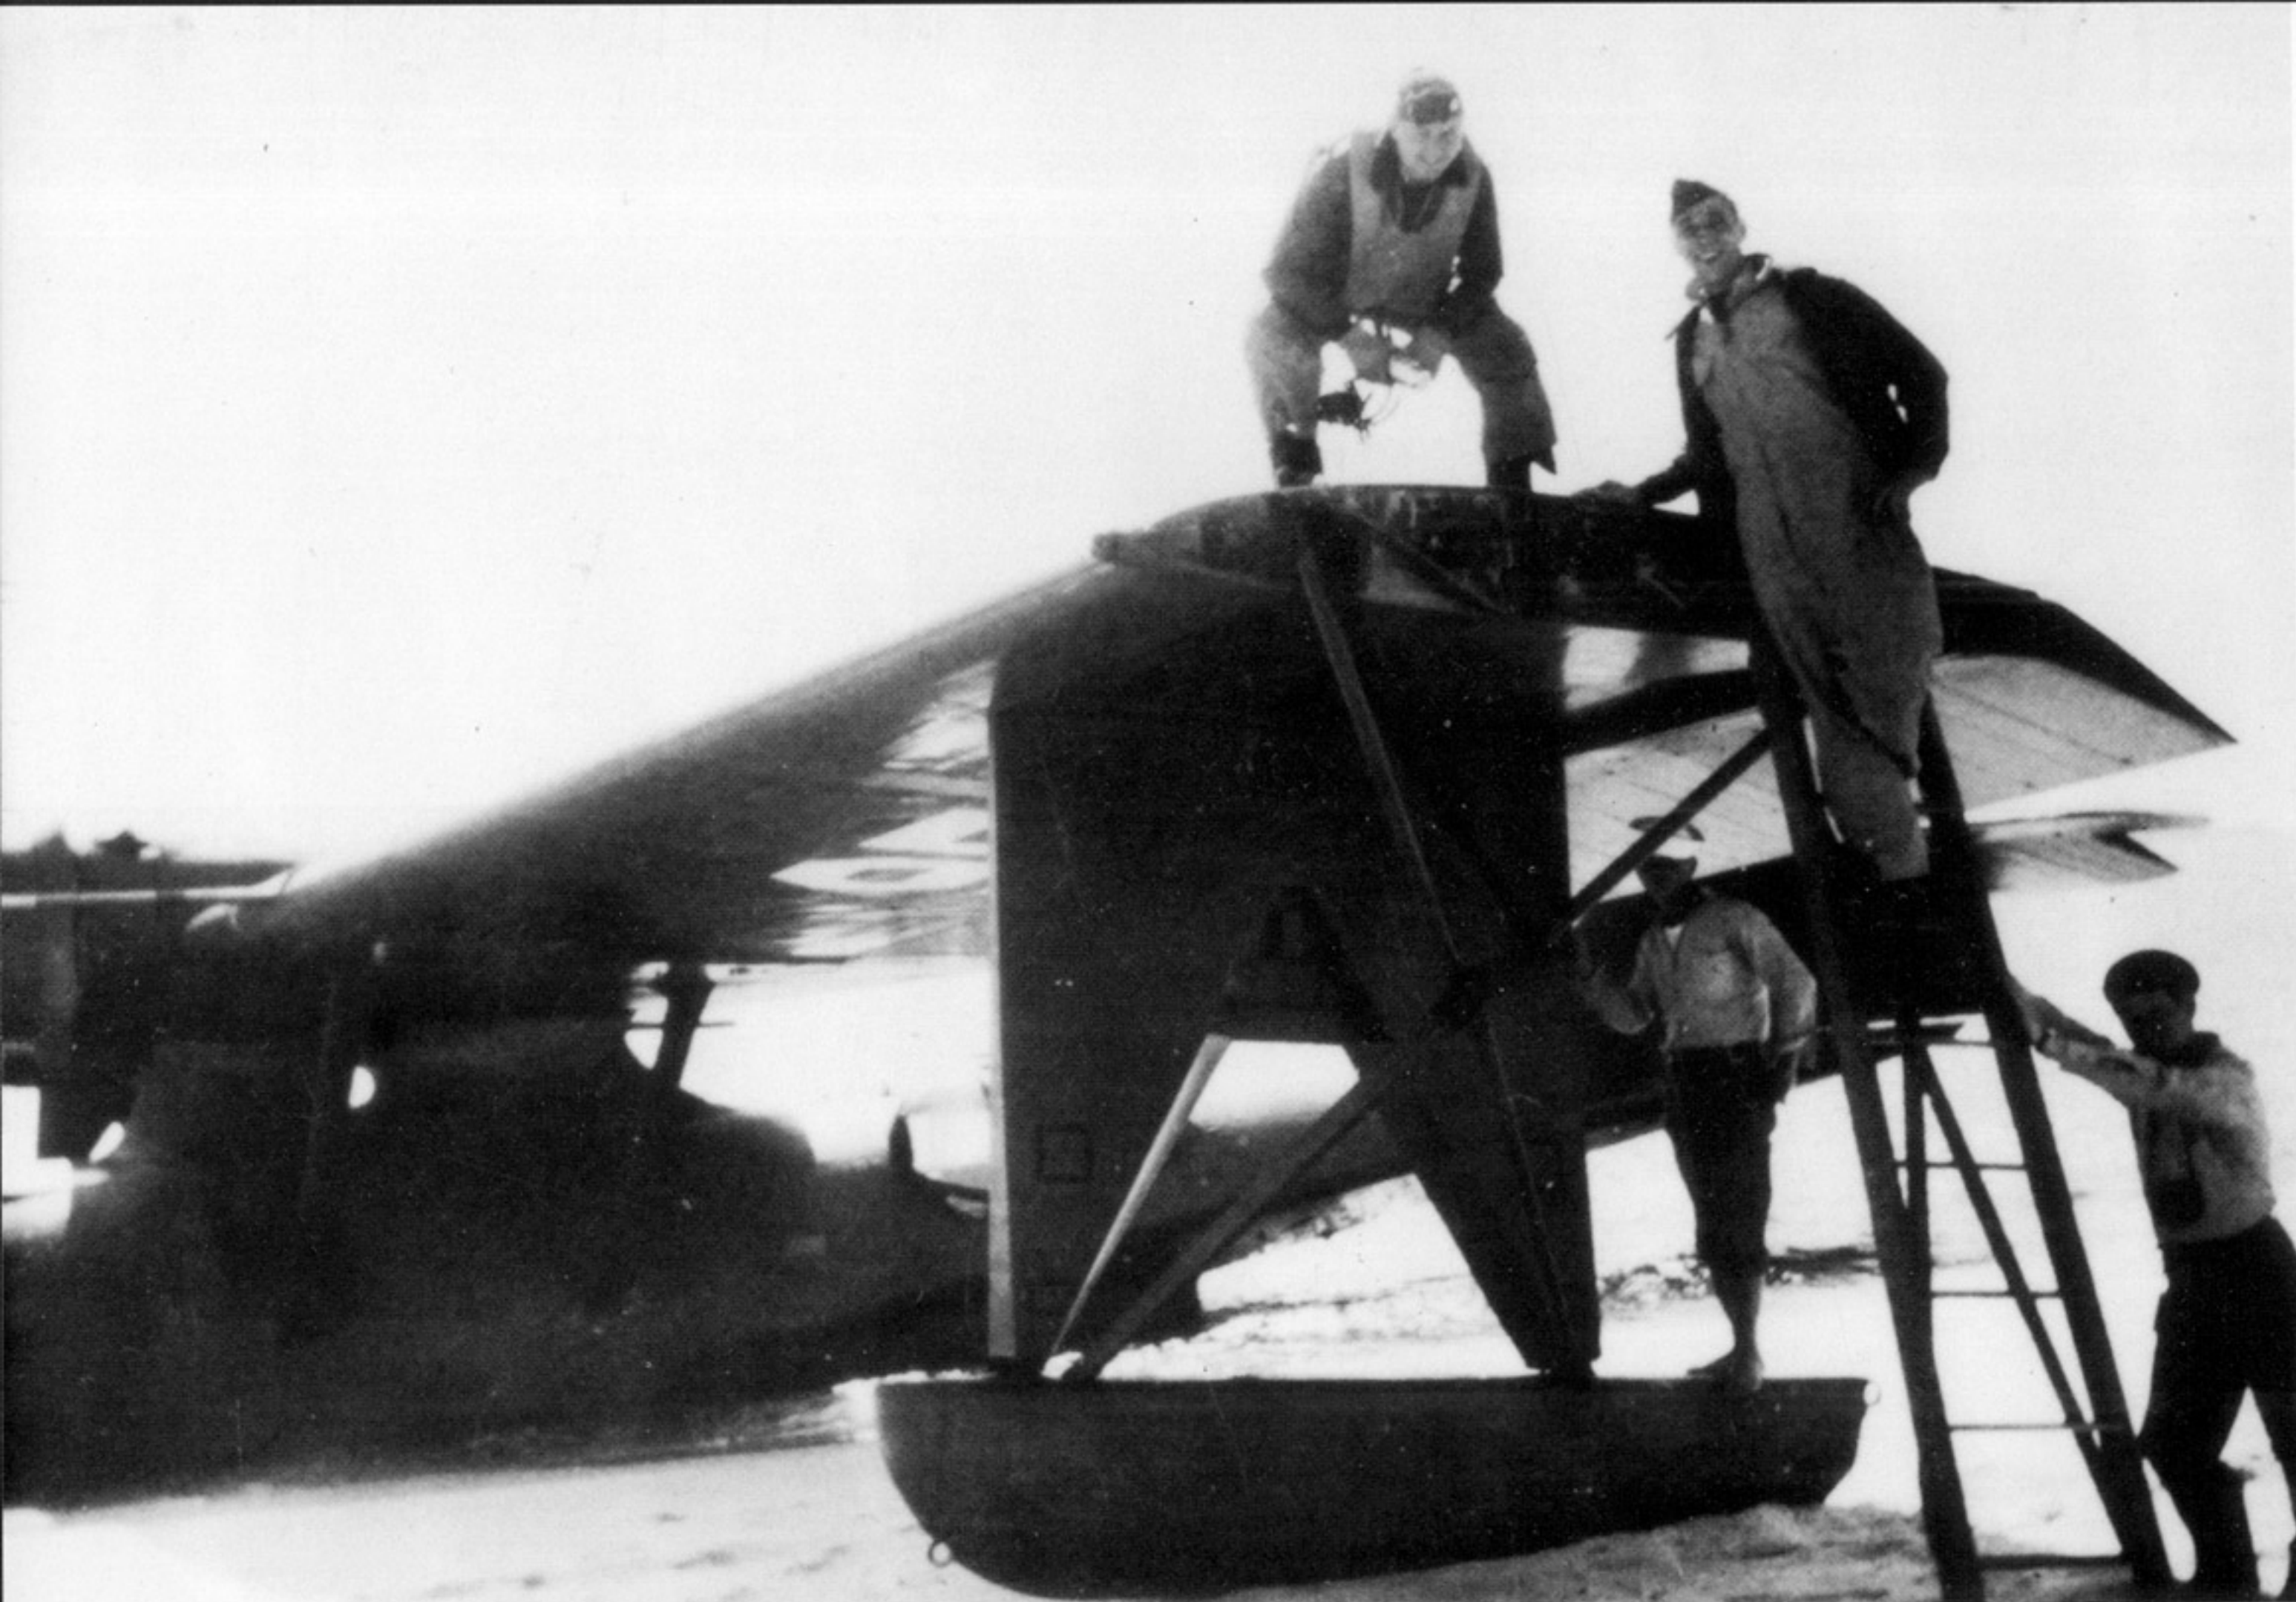
This PB4Y-1, beached on the Naval Air Station Pensacola, Florida, shows one way to change crews between training flights. The wing tip float is in the full down position and is resting on the sand. The X shaped struts are the float actuating and support struts.

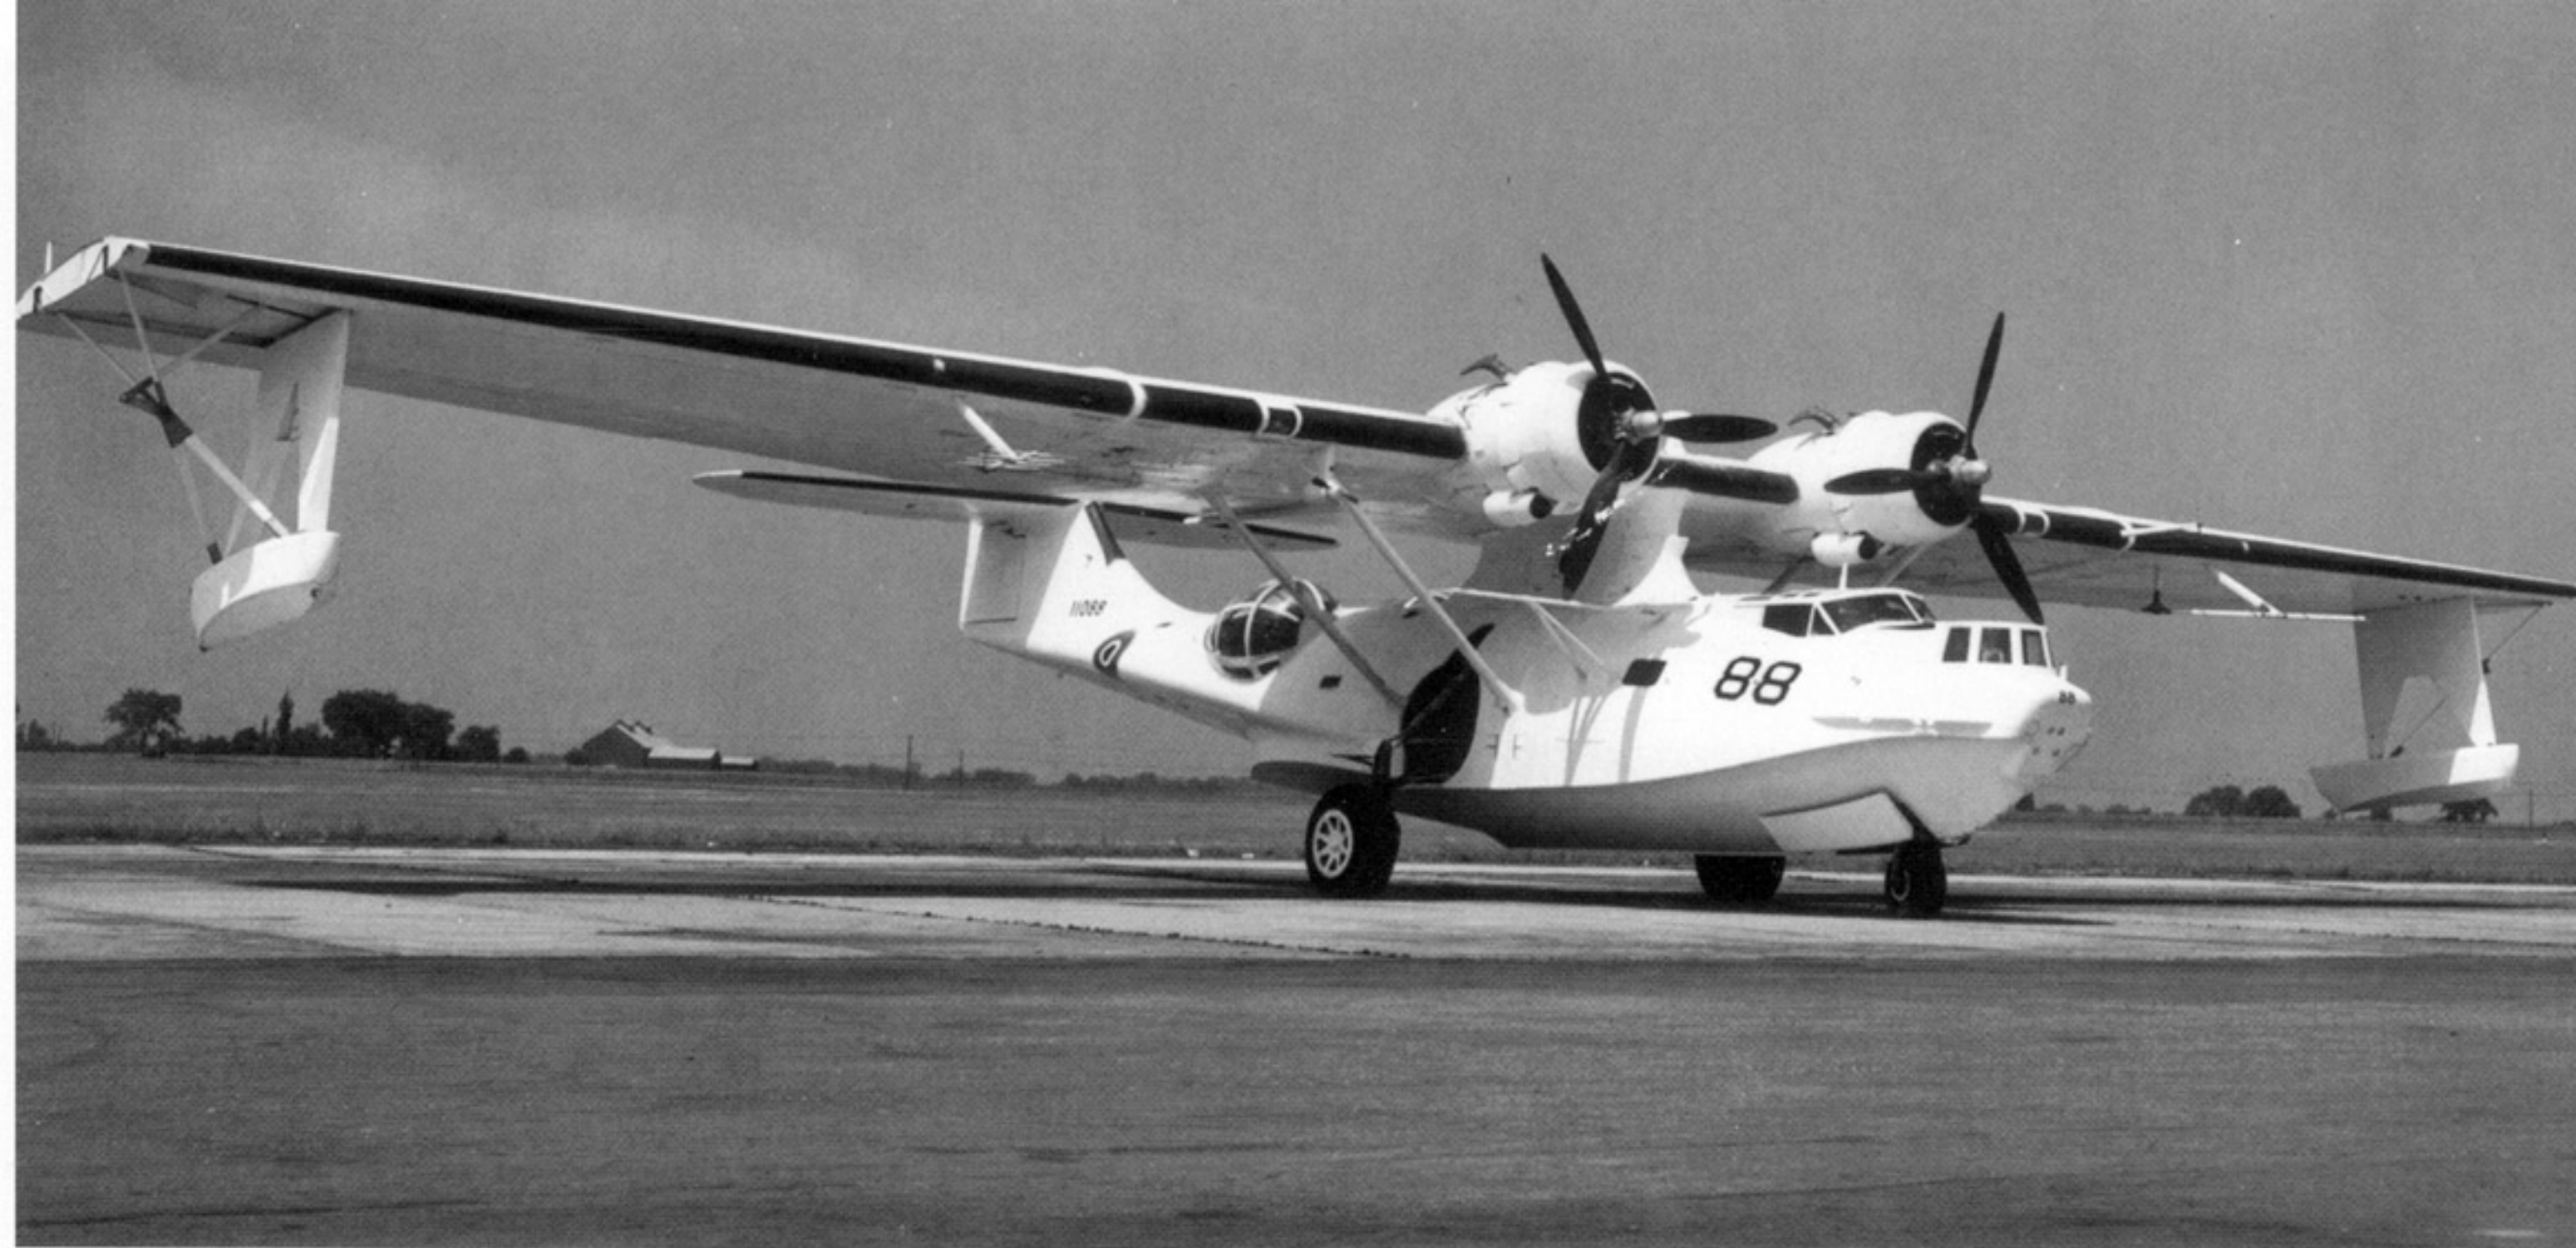
Normally, when operating from land bases, the wing tip floats were retracted for takeoff and flight, but were lowered to serve as post flight tie-downs. The strut coming back to the wing from the X float support struts was the float retraction linkage strut. When retracting, the float supports folded inward at the cross of the "X". This is a Canadian-built Vickers Canso A.

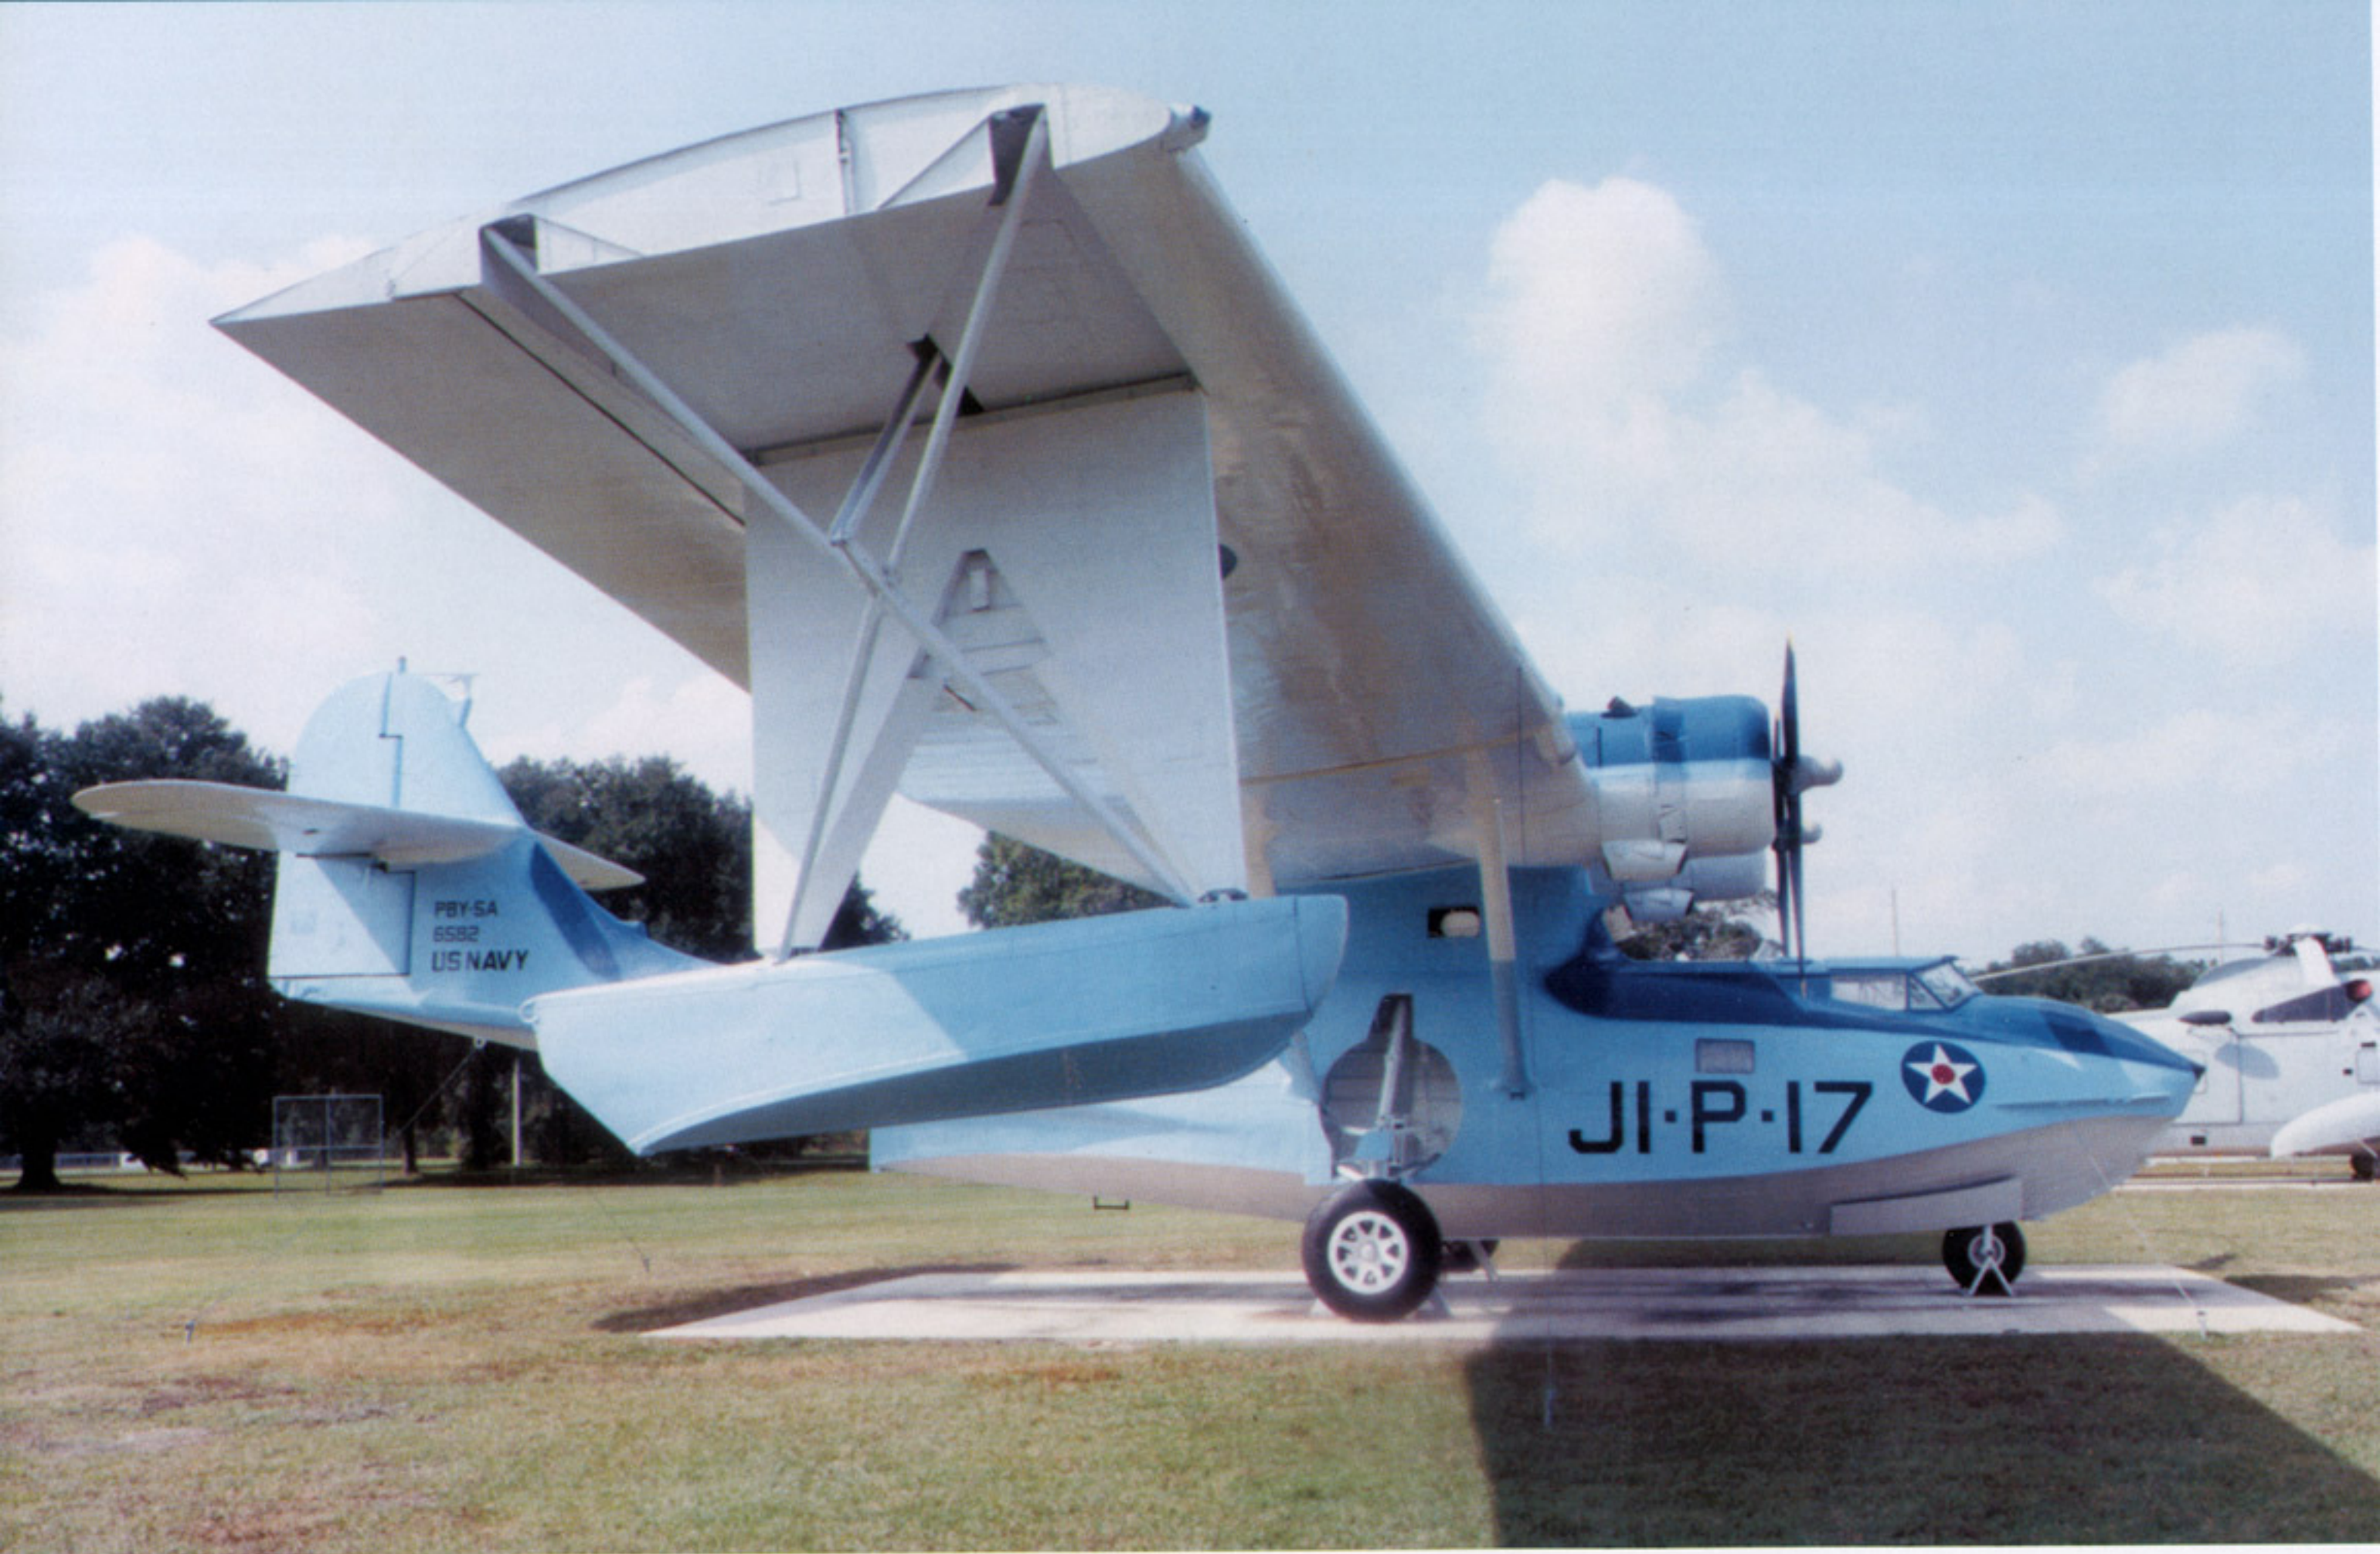
This restored PBX-5A is on display at Naval Air Station Jacksonville, Florida. The wing tip floats are in the full down position. The strut coming back off the strut support struts is the retraction linkage which retracts into the well within the float well. The float support struts fold inward lying in the notches in the wing tip. The Jacksonville PBX was modified with the bow turret being removed and faired over. The aircraft was painted with the wrong colors and markings. In addition, the tail codes are presented wrong and the fuselage codes are presented wrong for this type of paint scheme. (Richard Dann)

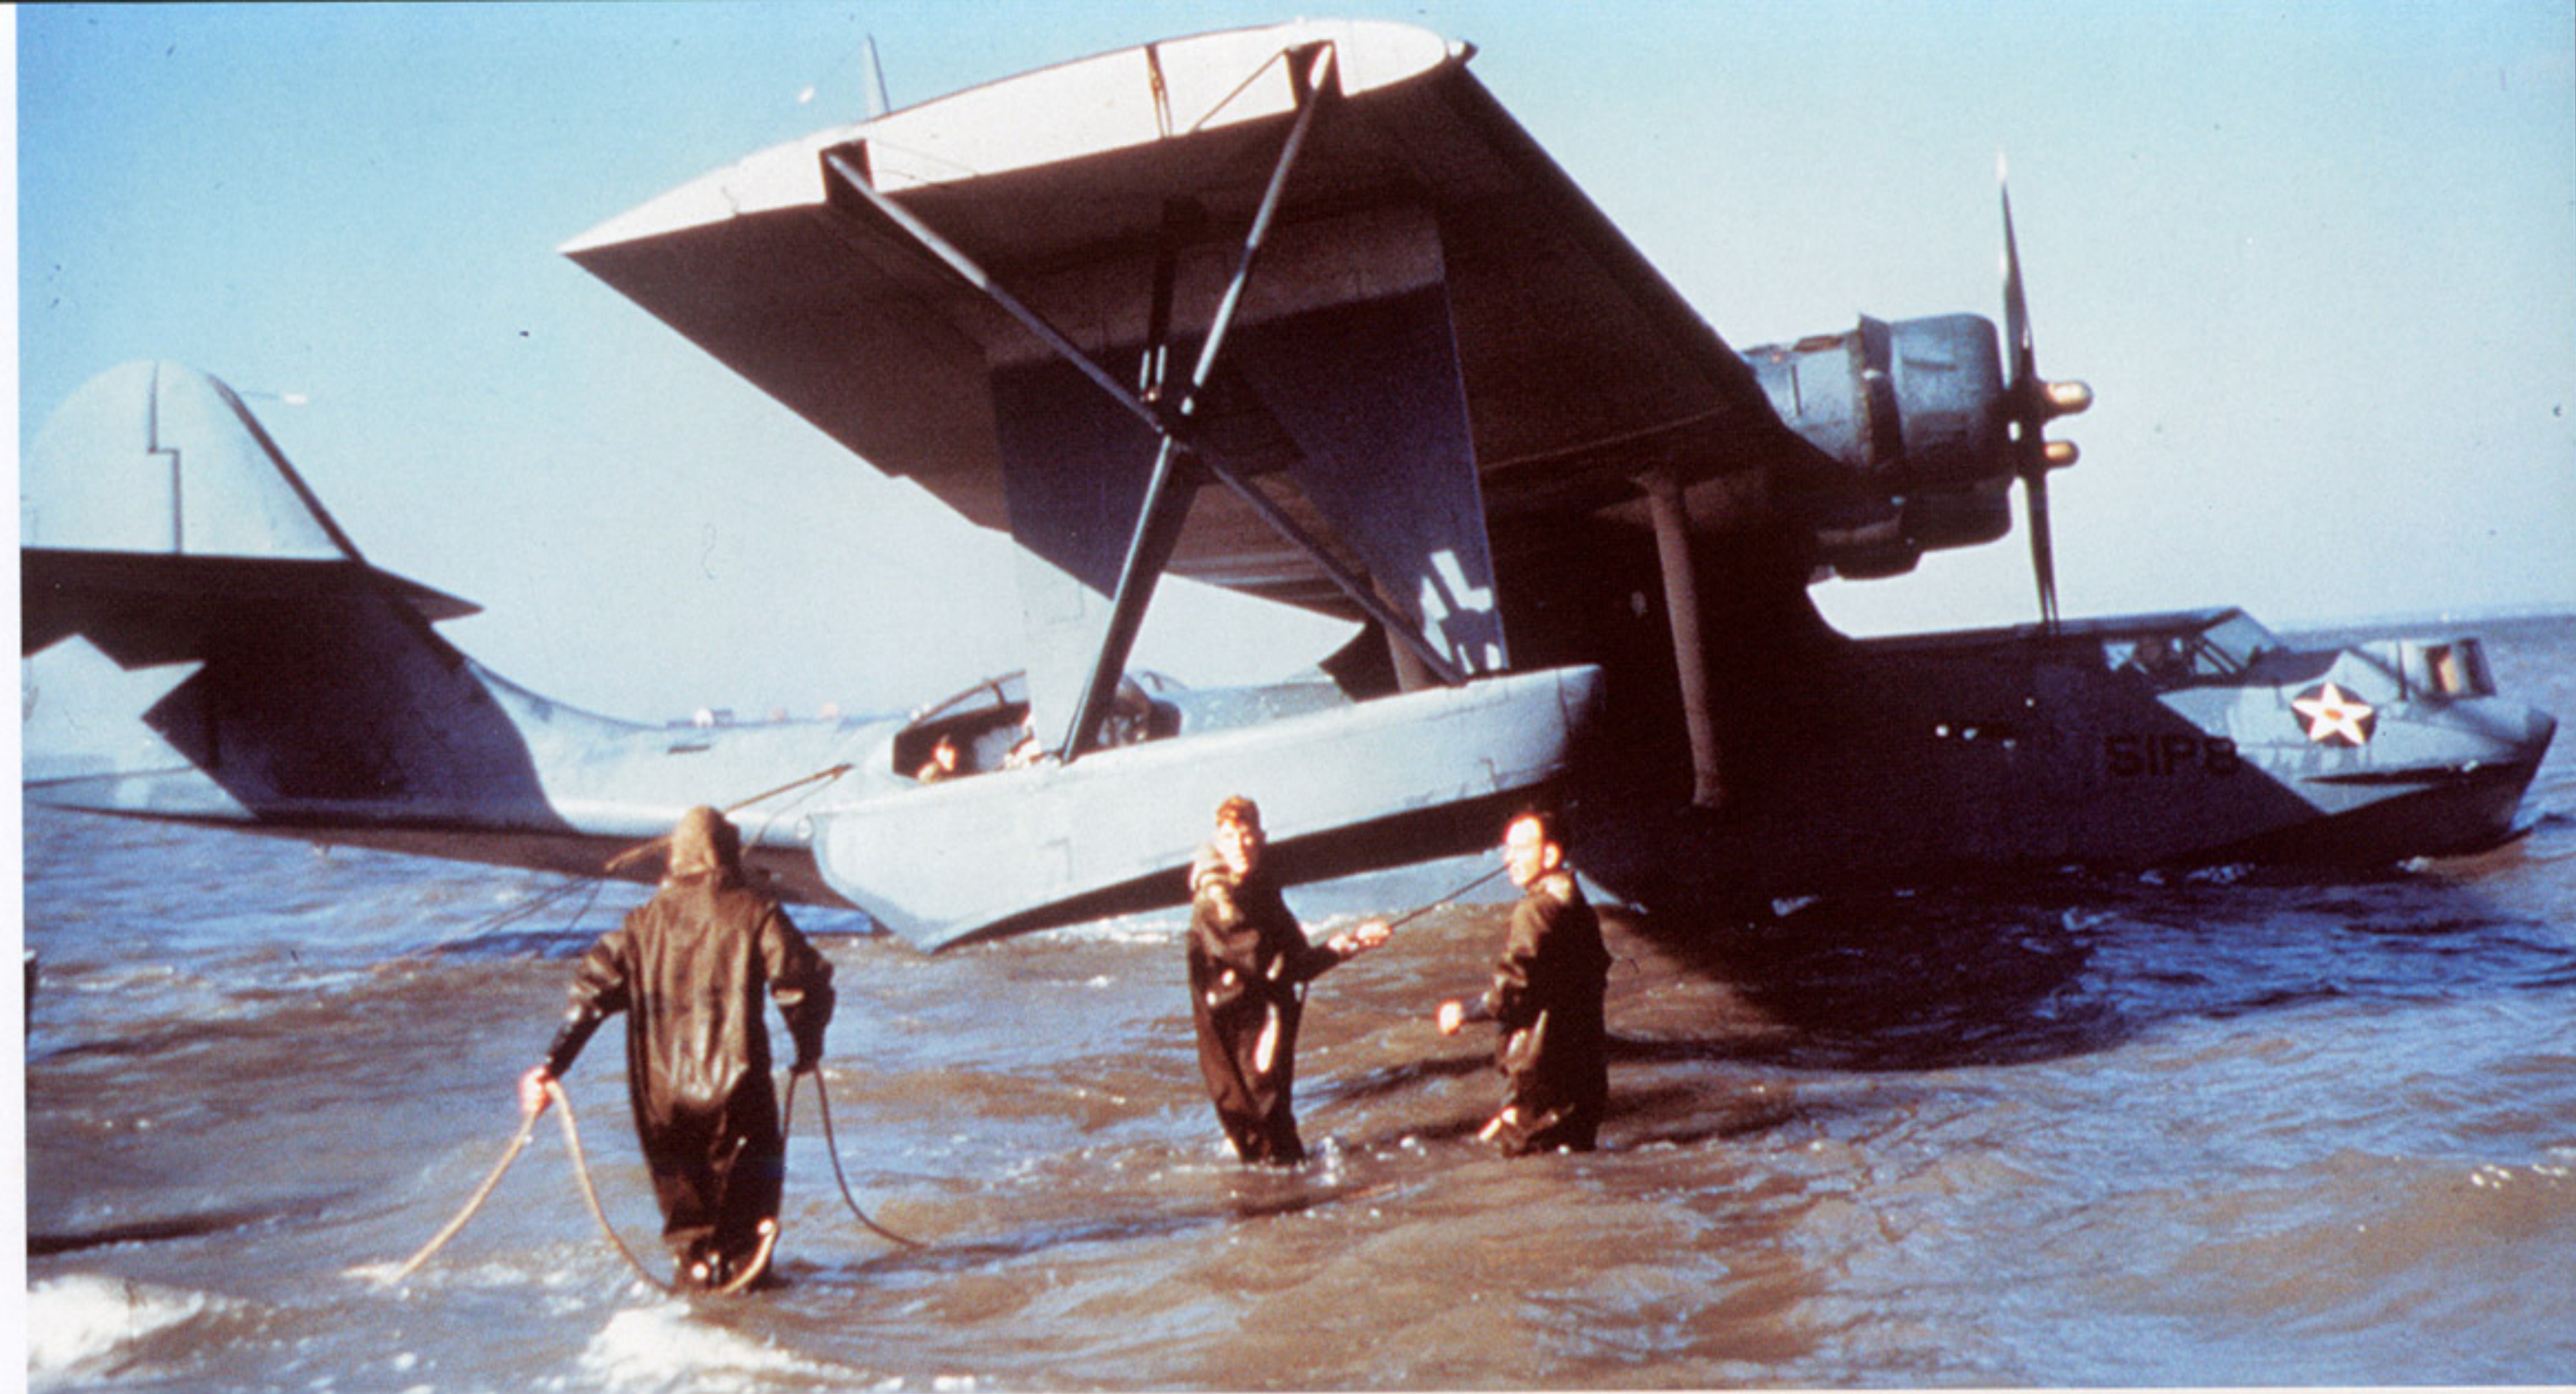
An alternative to beaching the aircraft on a ramp was operating from a suitable beach, especially for short duration training flights. NAS Pensacola routinely operated both primary and advance patrol plane training from beaches from before the First World War until after the Second World War. Crewmen in "boots" (anti-exposure suits) are attaching handling lines to the wing tip float tie-downs to be used to reposition the aircraft for engine start and launch for the next flight. (W. Derby via J. Ethell)
